**NASA CONTRACTOR  
REPORT**

NASA CR-2884

**LOAN COPY: RETURN TO  
AFWL TECHNICAL LIBRARY  
KIRTLAND AFB, N. M.****MODEL PREDICTIONS OF WIND  
AND TURBULENCE PROFILES  
ASSOCIATED WITH AN ENSEMBLE  
OF AIRCRAFT ACCIDENTS**

AERONAUTICAL RESEARCH ASSOCIATES OF PRINCETON, INC.

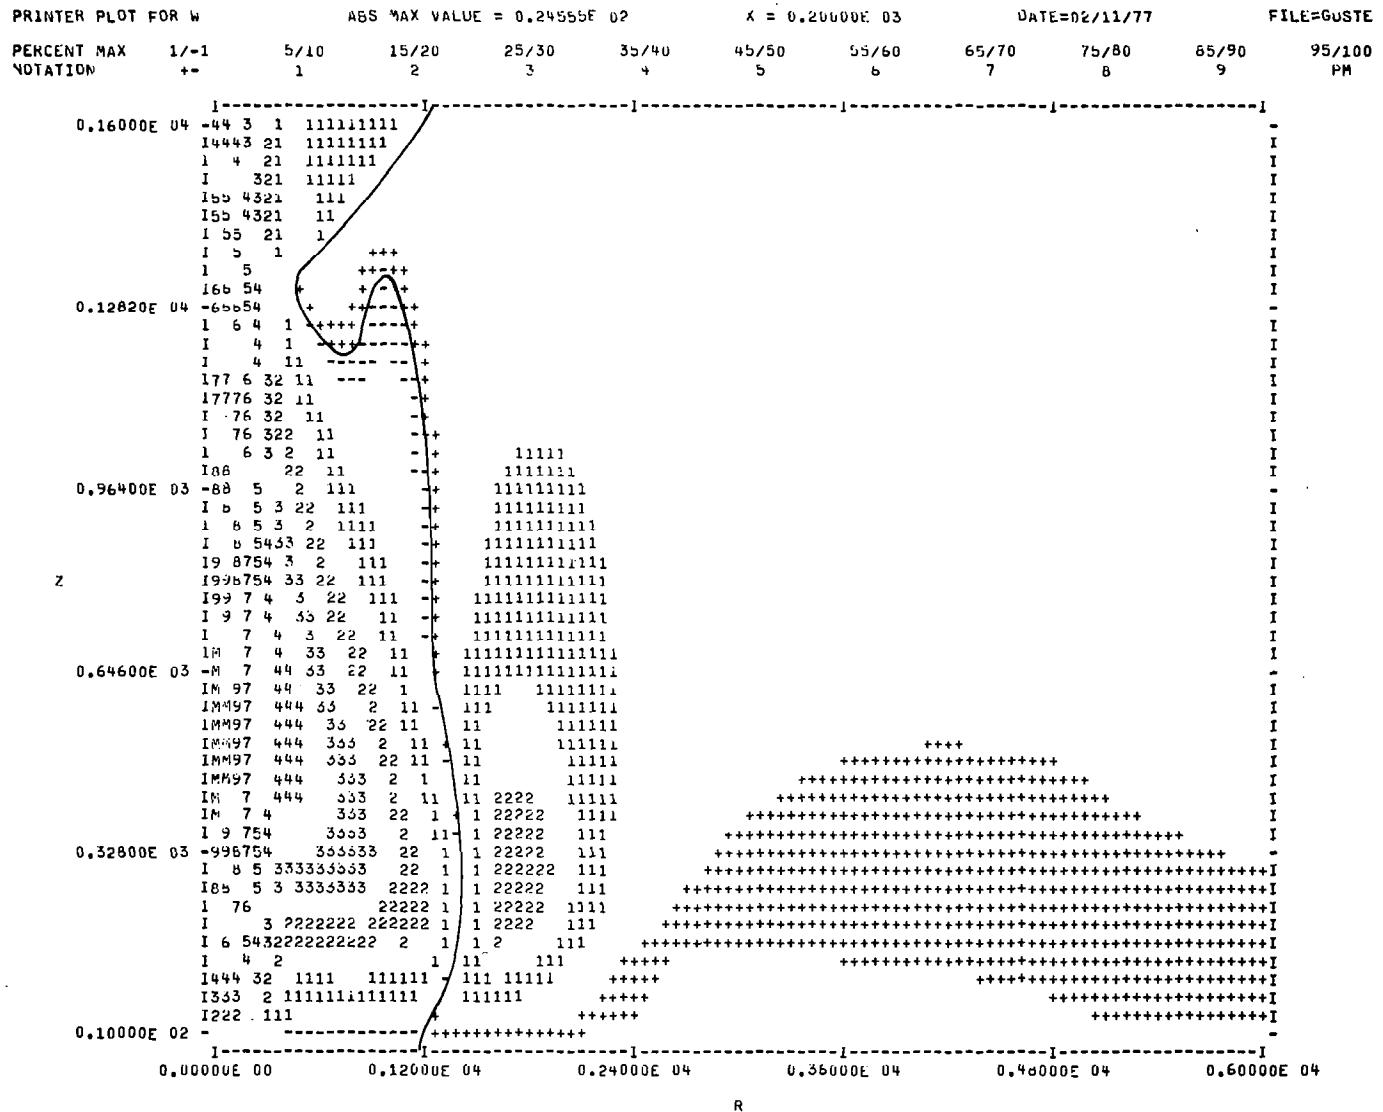
Figure 4.2.5. Normalized mean vertical velocity contours as a function of  $z$  and  $R$  for an axis-symmetric gust front with a 500 m radius downdraft at  $t = 200$  sec. [See figure 2.3.2 for explanation of notation.]

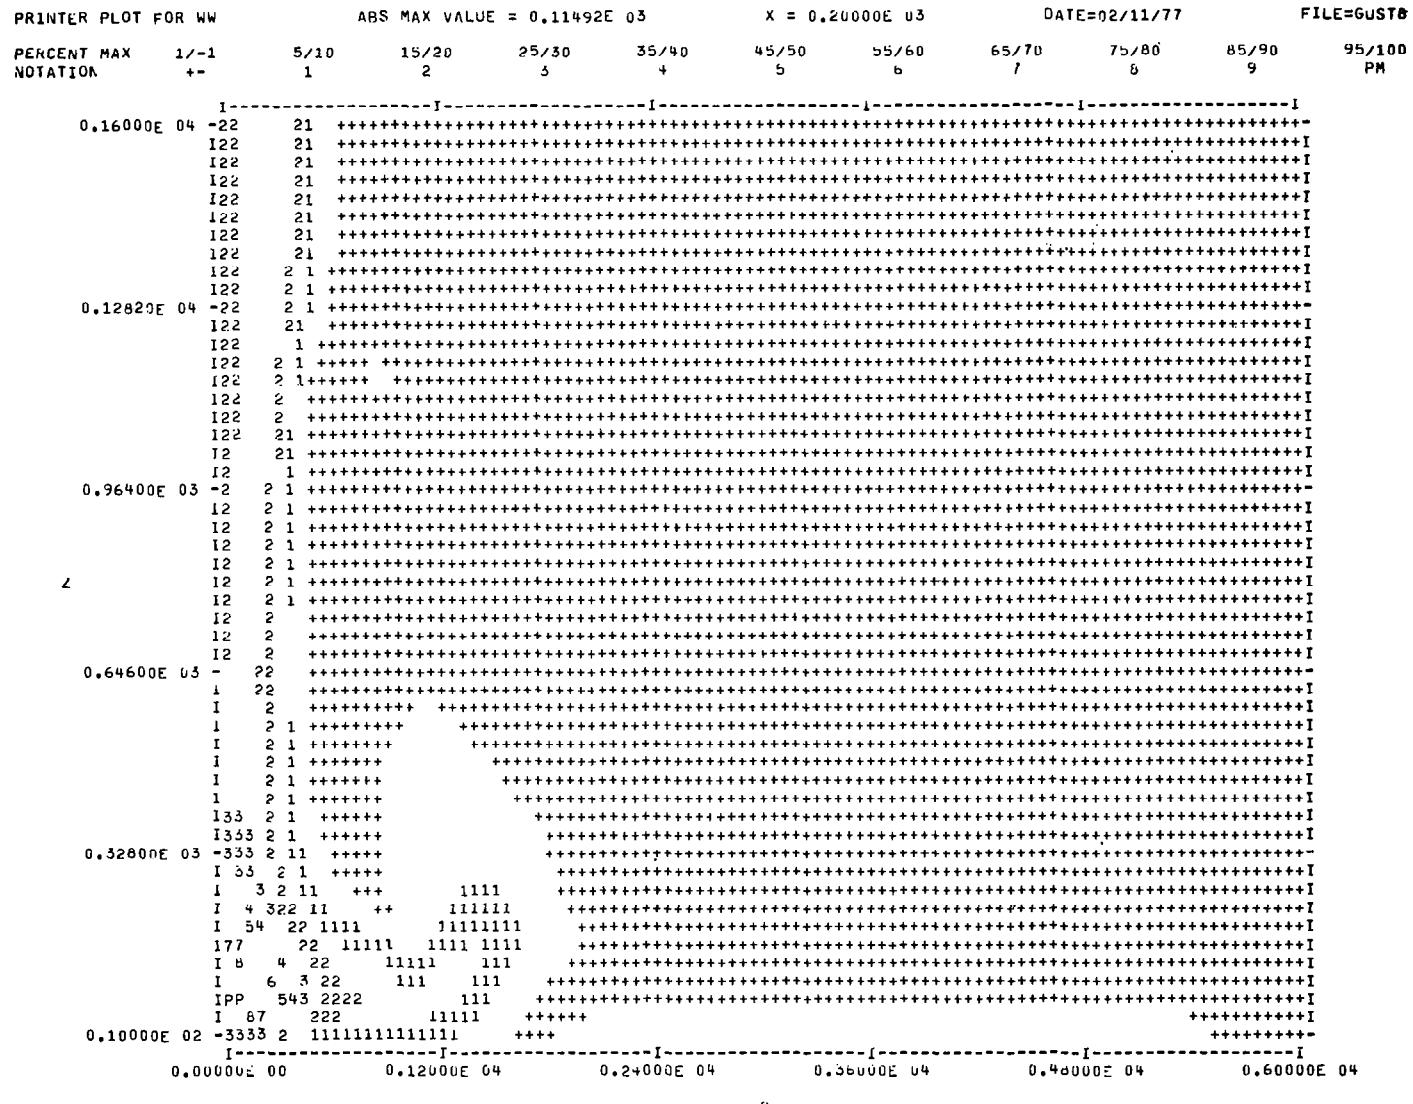
Figure 4.2.6. Normalized variance of vertical velocity contours as a function of  $z$  and  $R$  for an axisymmetric gust front with a 500 m radius downdraft at  $t = 200$  sec. [See figure 2.3.2 for explanation of notation.]  
 100

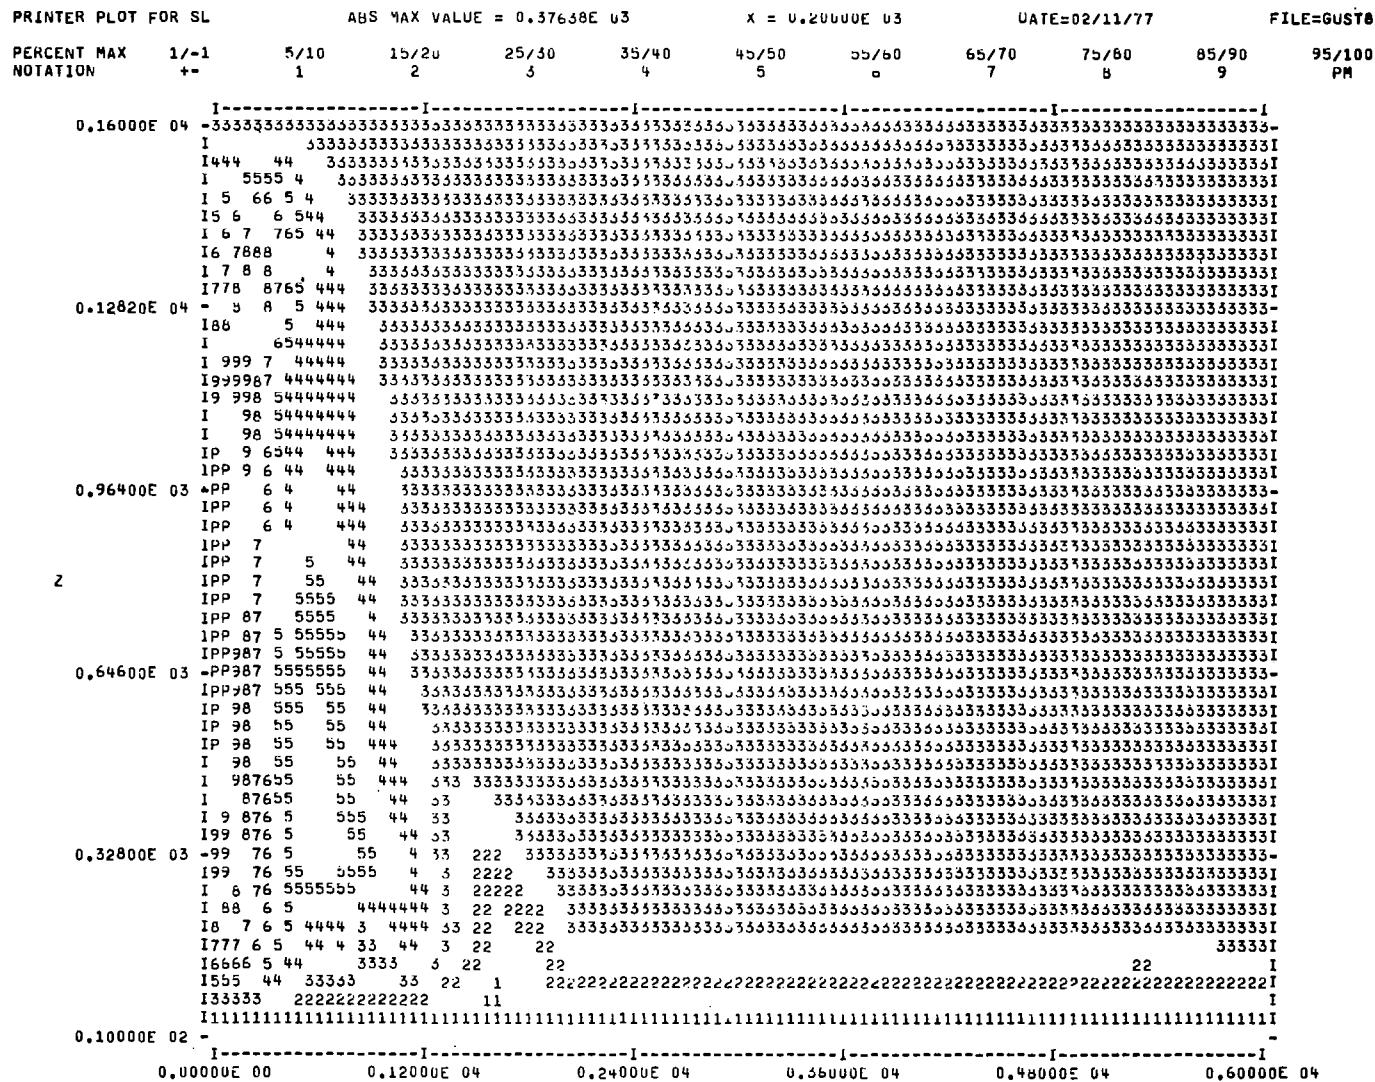
Figure 4.2.7. Normalized scale of turbulence contours as a function of  $z$  and  $R$  for an axisymmetric gust front with a 500 m radius downdraft at  $t = 200$  sec. [See figure 2.3.2 for explanation of notation.]

For modeling purposes A.R.A.P. has chosen the same small axisymmetric gust front as used in the Denver case (figures 4.2.2 - 4.2.7). The landing trajectory is a three degree glideslope approach into the storm followed by an increase to a six degree glideslope due to the downdraft (figure 4.3.2). The vertical placement of this trajectory was chosen such that the initial headwind encounter occurs at 220 m. The complete horizontal wind profile is shown in figure 4.3.3 as a function of altitude. This trajectory and storm cell model results in a loss of  $32 \text{ m/sec}$  in an altitude of 130 m. This is a wind shear of  $.25 \text{ sec}^{-1}$ , a dangerously high shear to encounter. The corresponding vertical wind velocity profile is shown in figure 4.3.4. The maximum downdraft velocity of

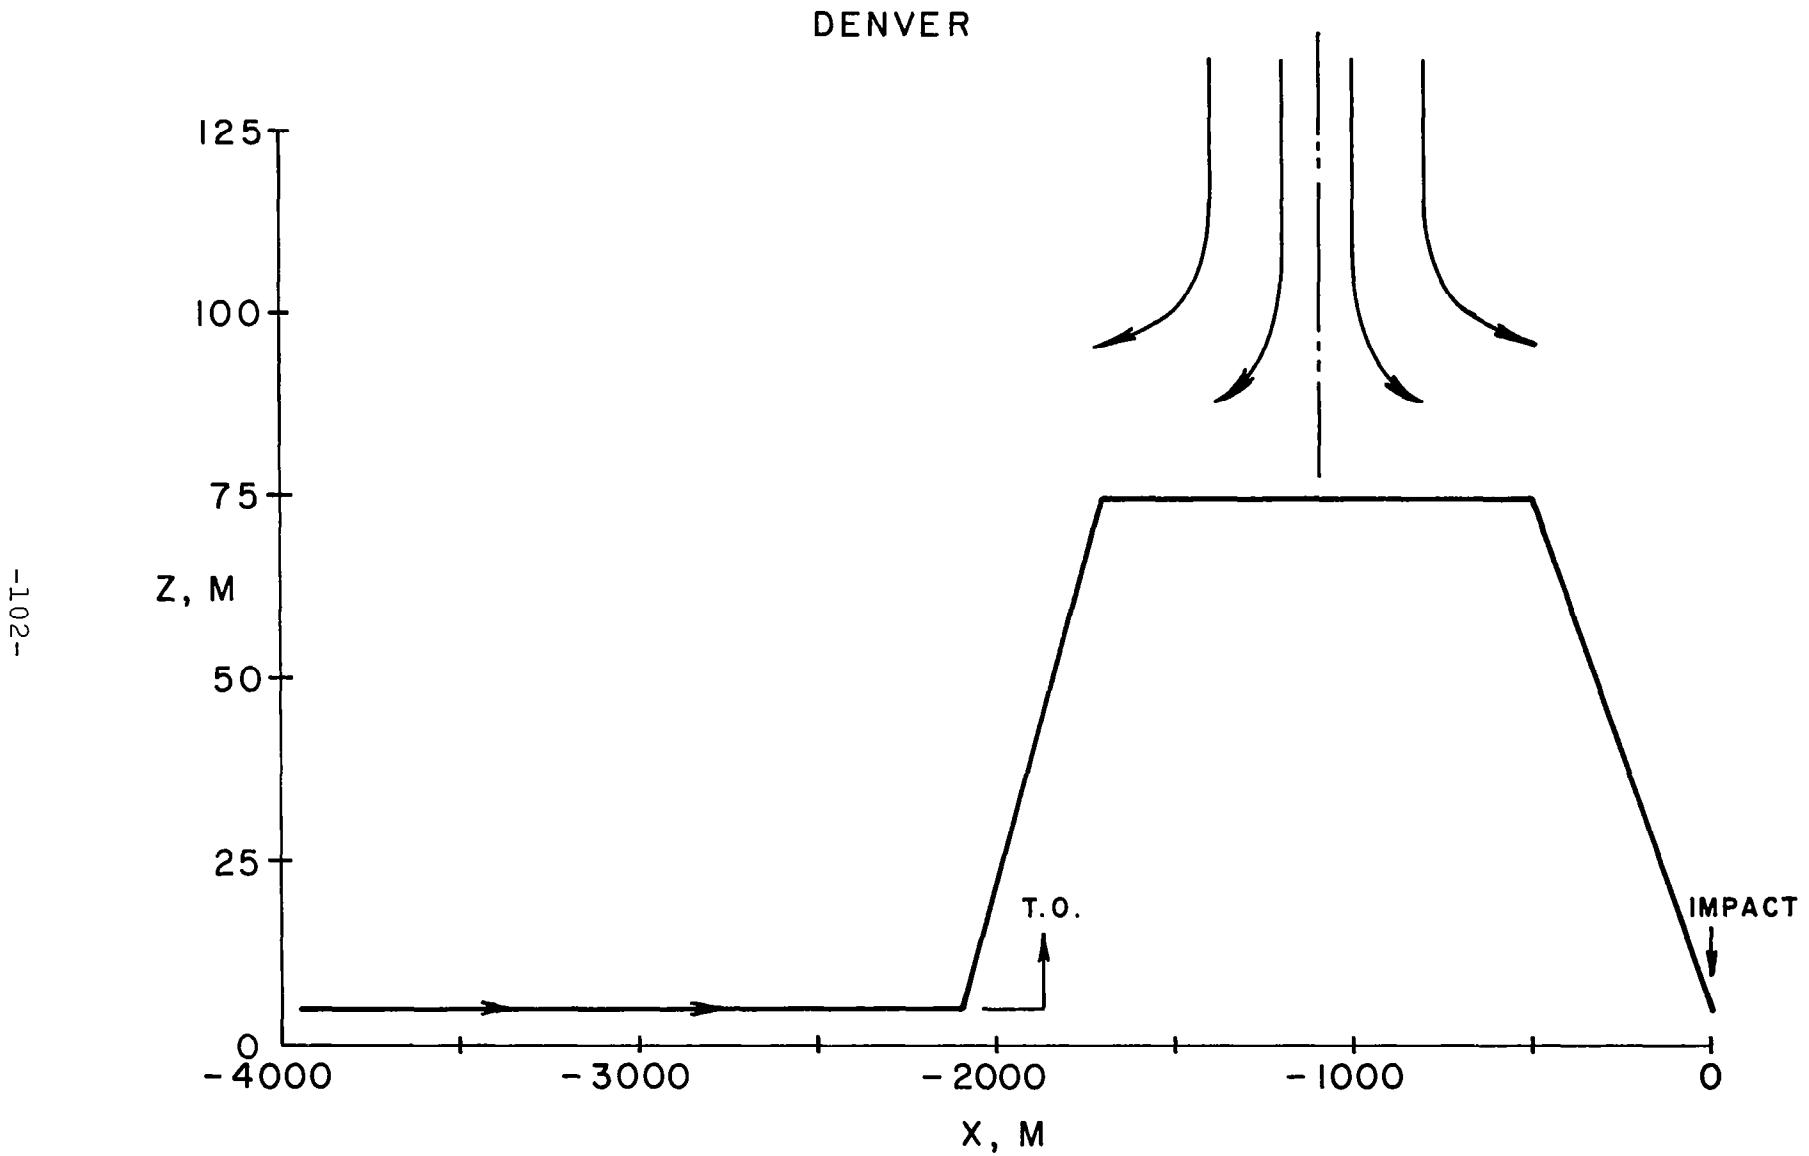
Figure 4.2.8. Approximate aircraft trajectory relative to storm cell and initial point of impact for Denver, Colorado, August 7, 1975 accident.

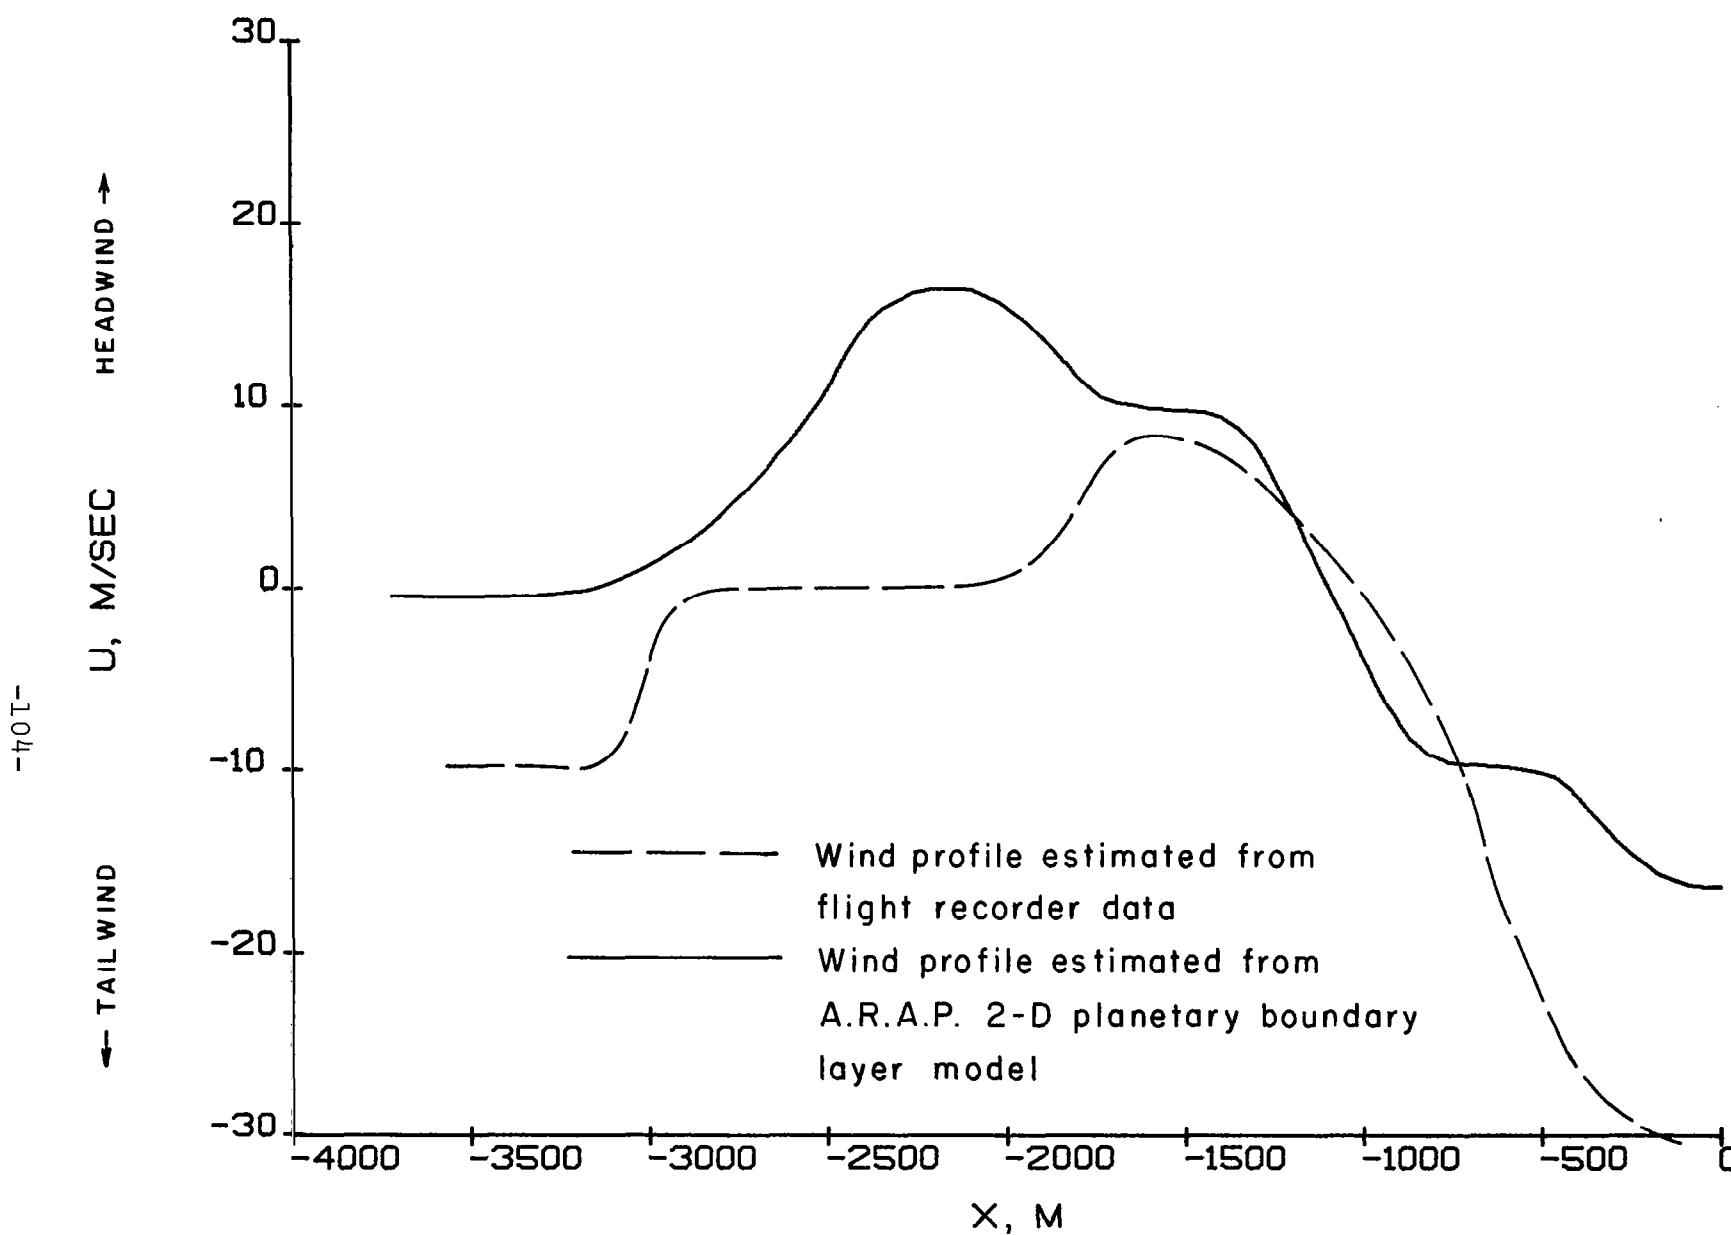
Figure 4.2.9. Velocity component of mean wind parallel to runway as a function of horizontal distance from the initial impact point (+ U, tailwind) for the Denver, Colorado, August 7, 1975 accident.

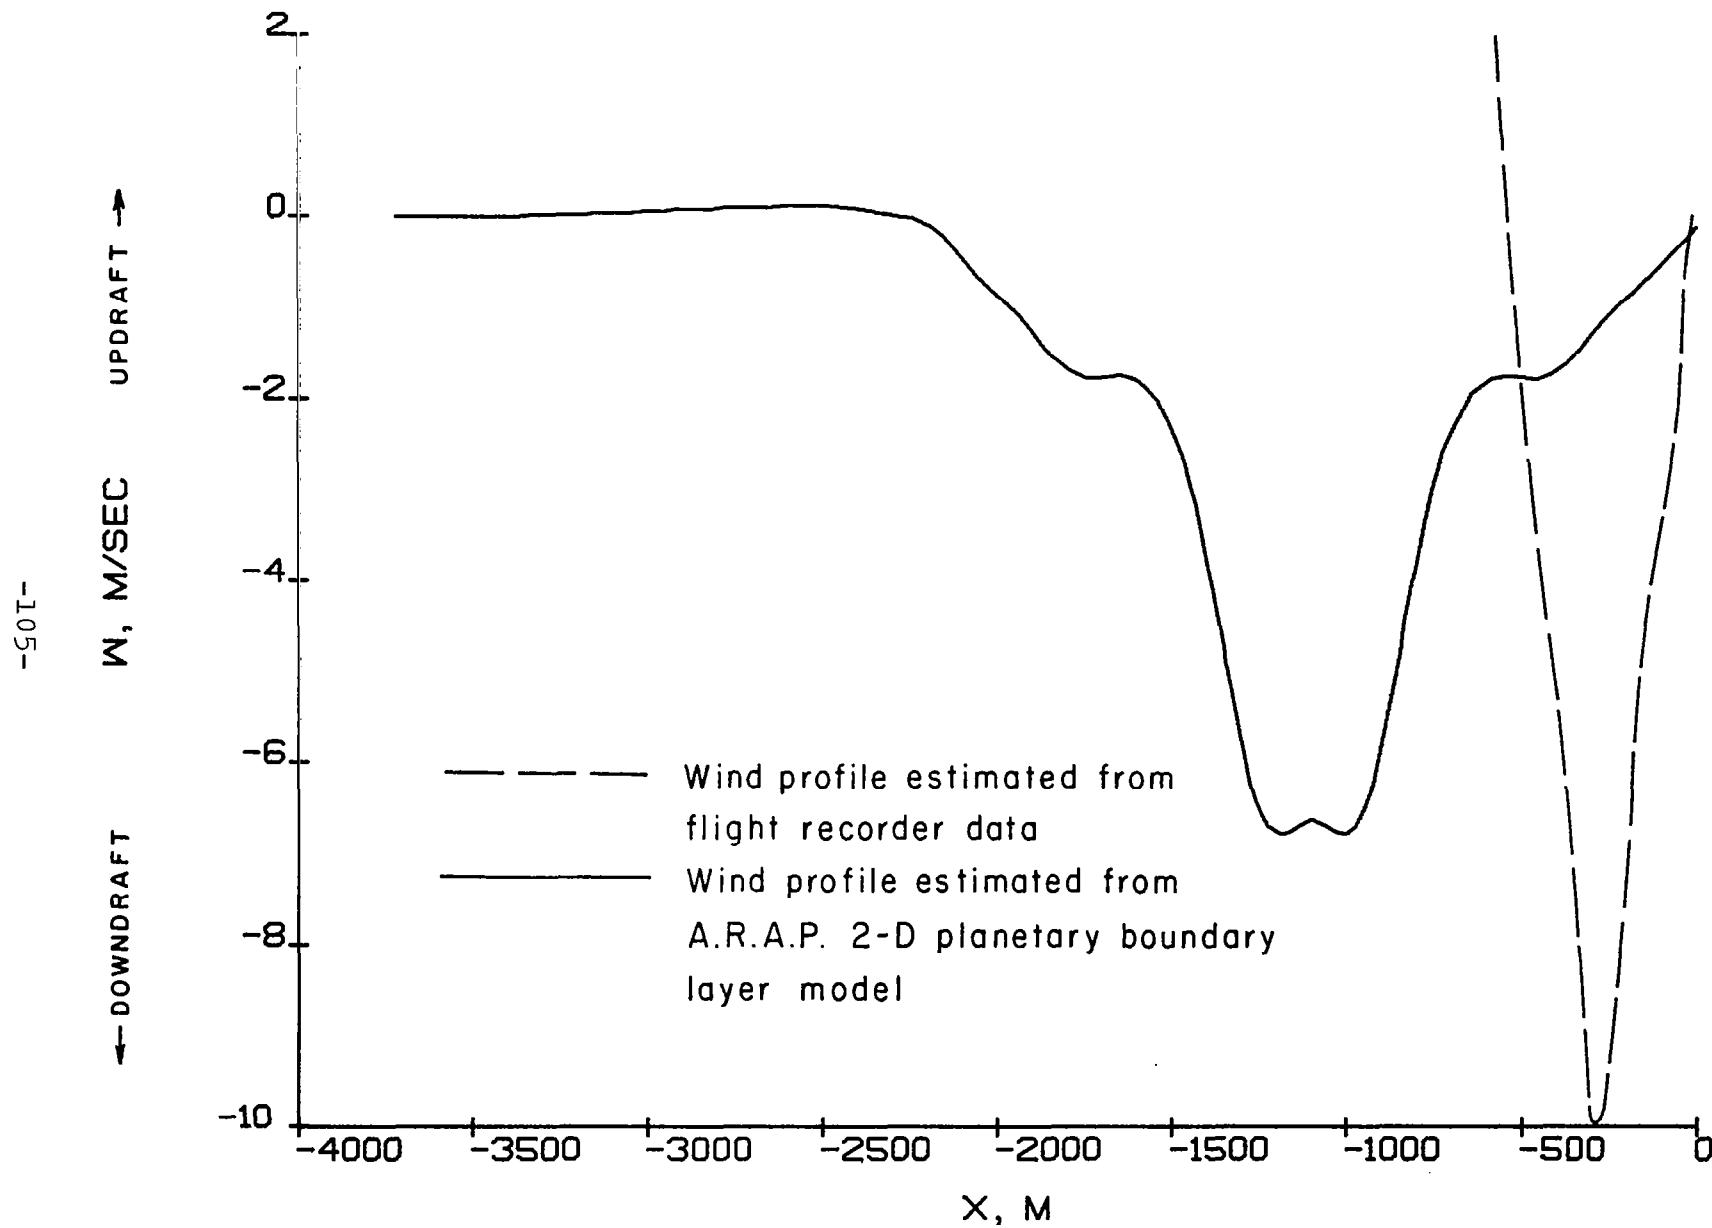
Figure 4.2.10. Vertical velocity component of mean wind as function of horizontal distance from the initial impact point (+ W, up) for the Denver, Colorado, August 7, 1975 accident.

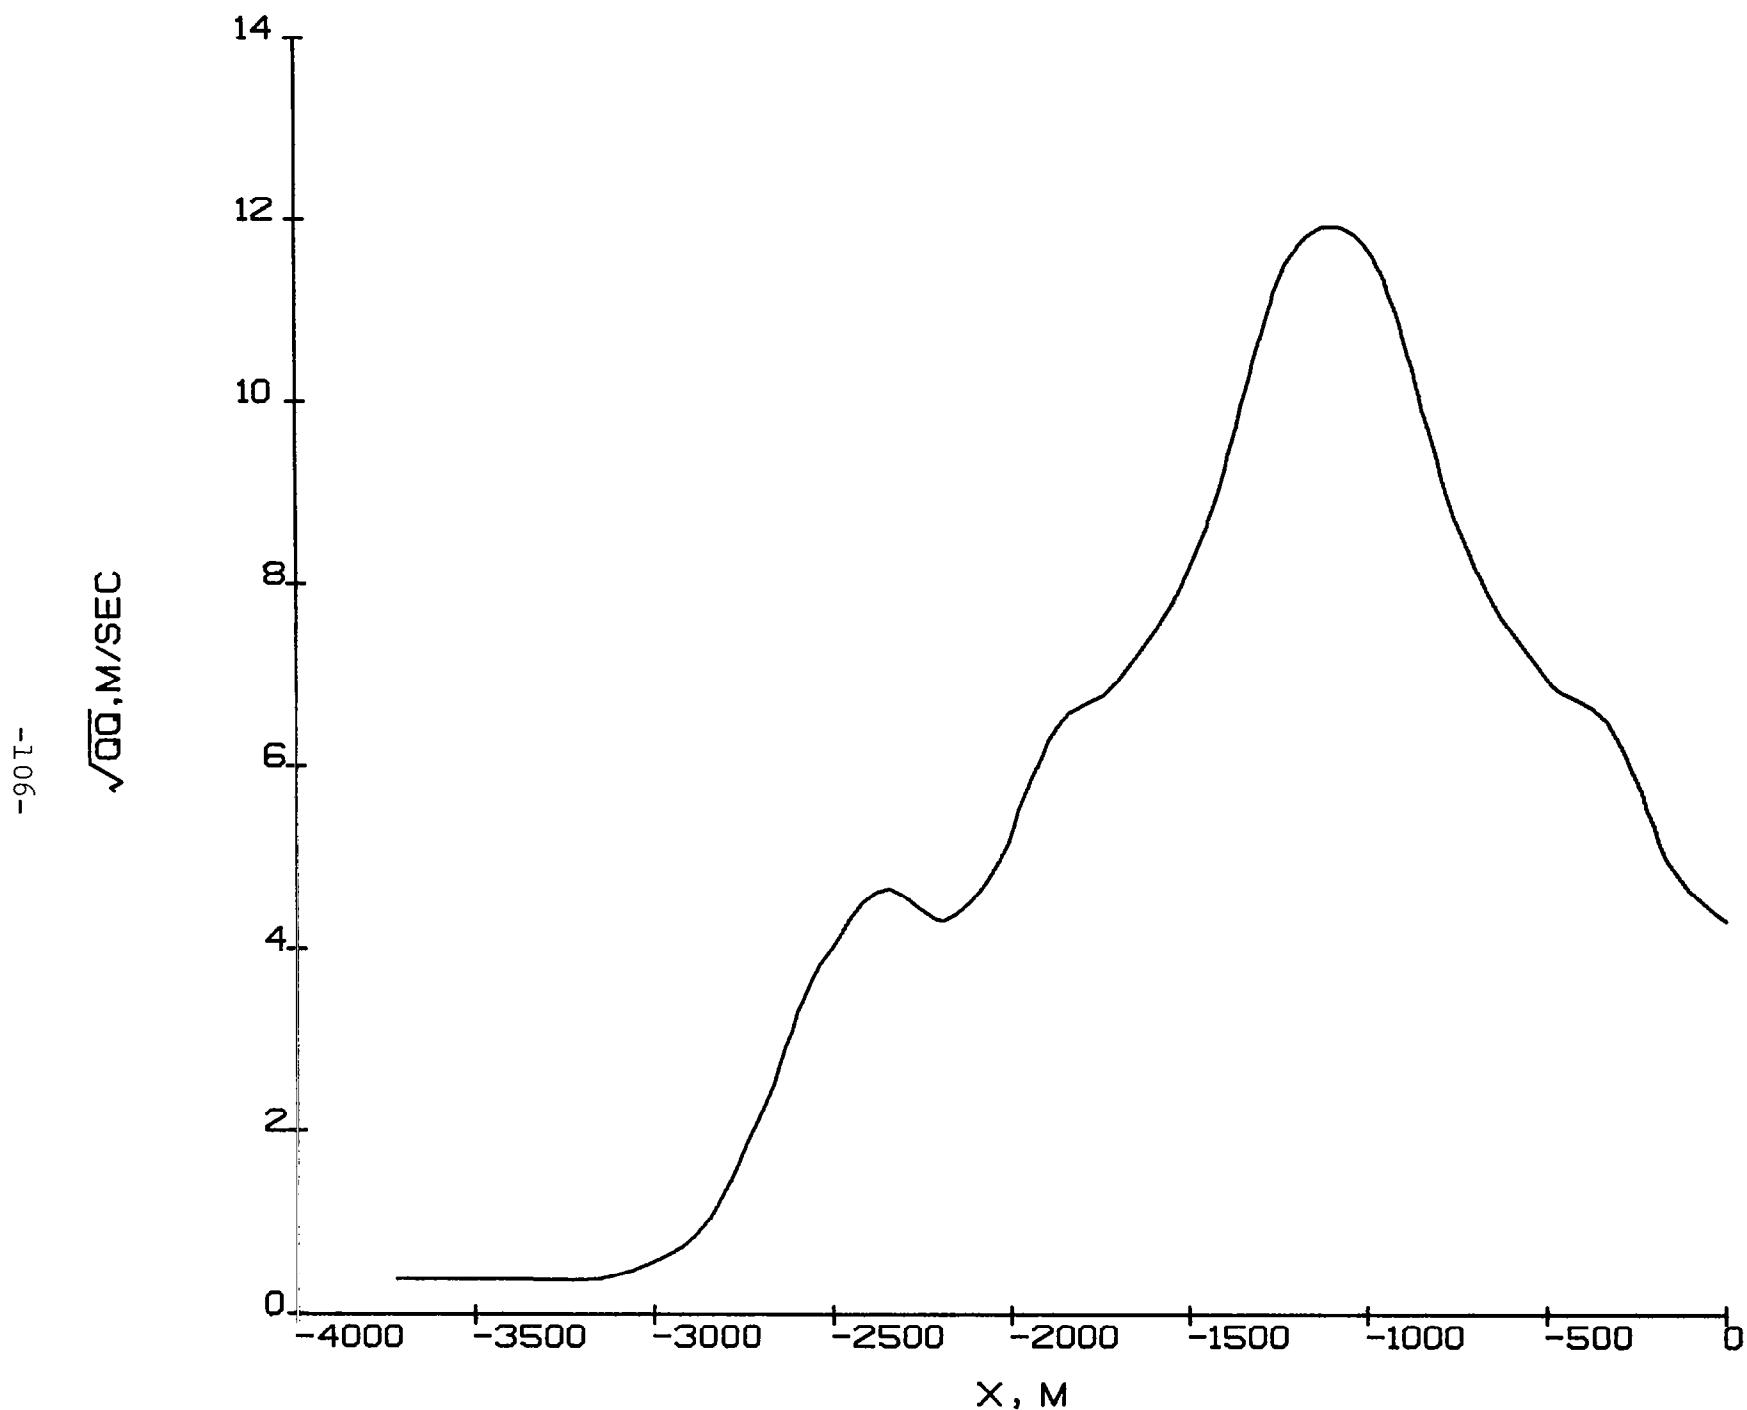
Figure 4.2.11. Variance of the total velocity as a function of horizontal distance from the

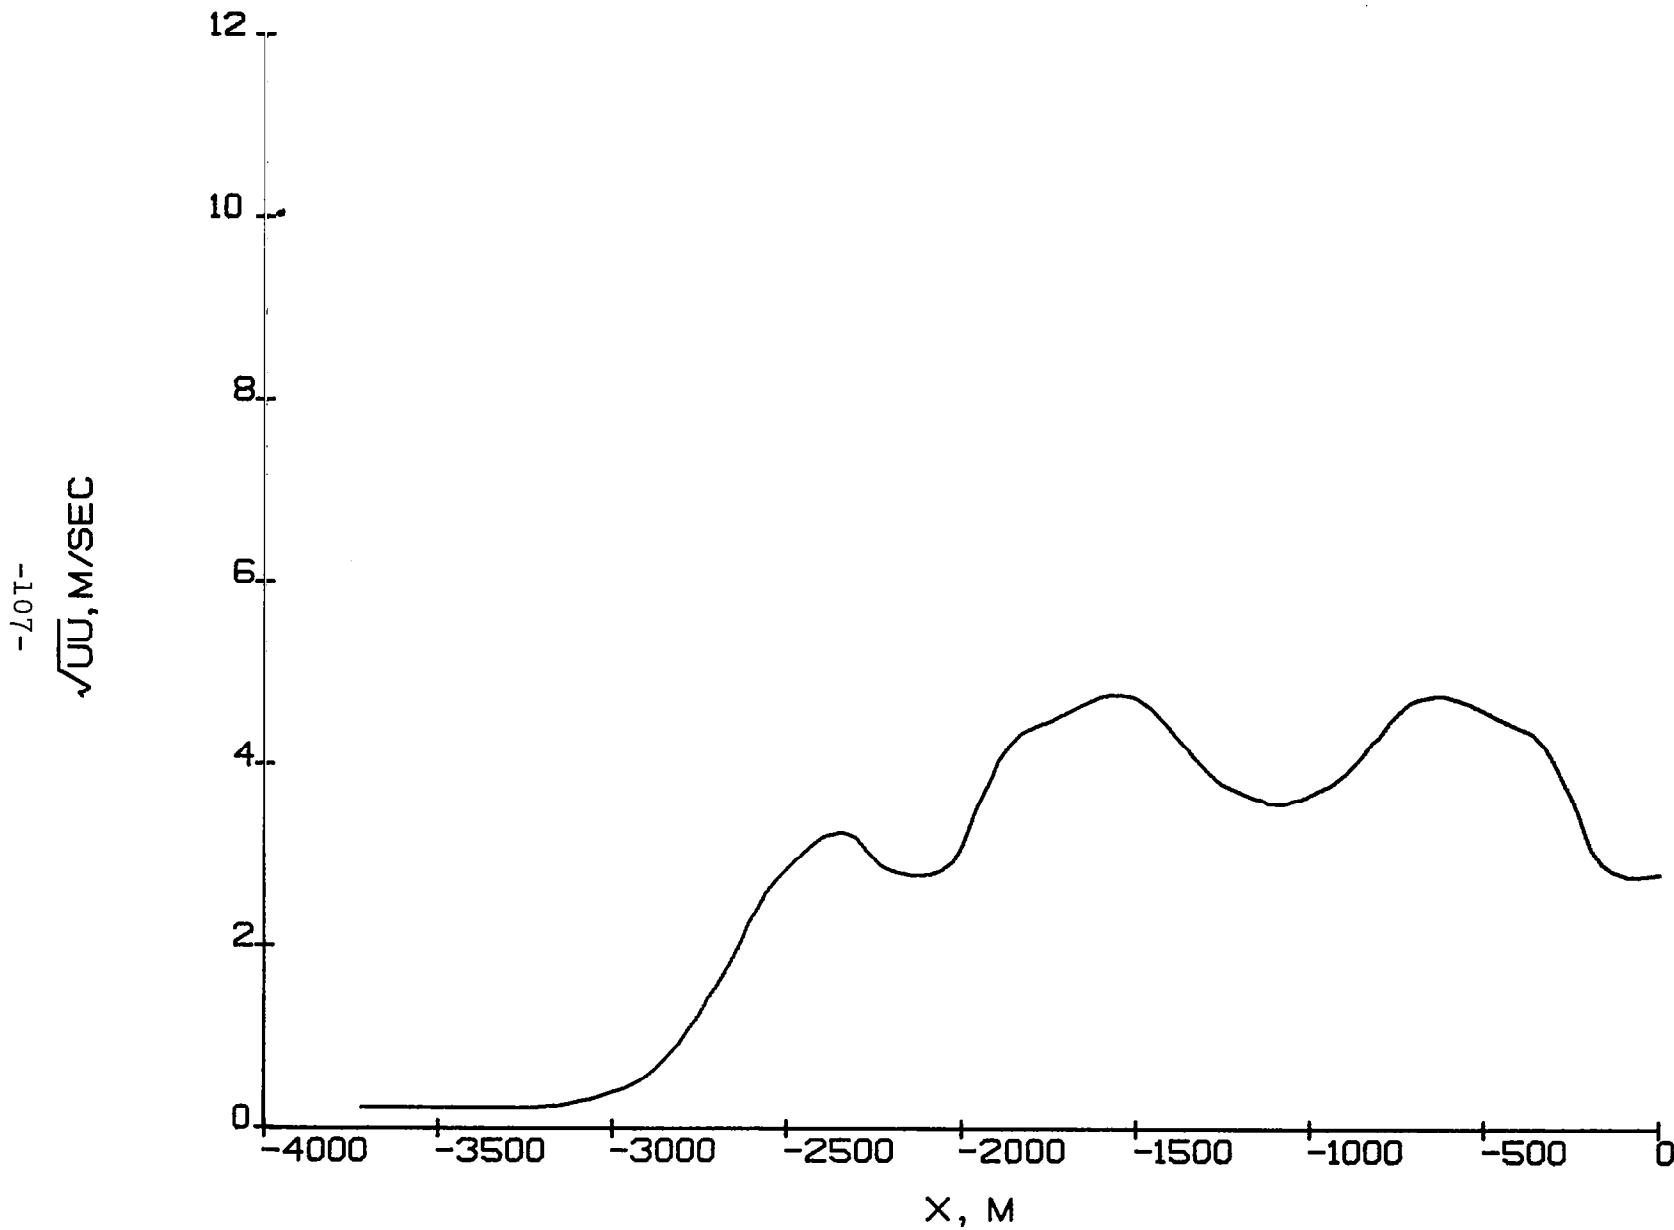
Figure 4.2.12. Variance of the wind parallel to runway as a function of horizontal distance from the initial impact point for the Denver, Colorado, August 7, 1975 accident.

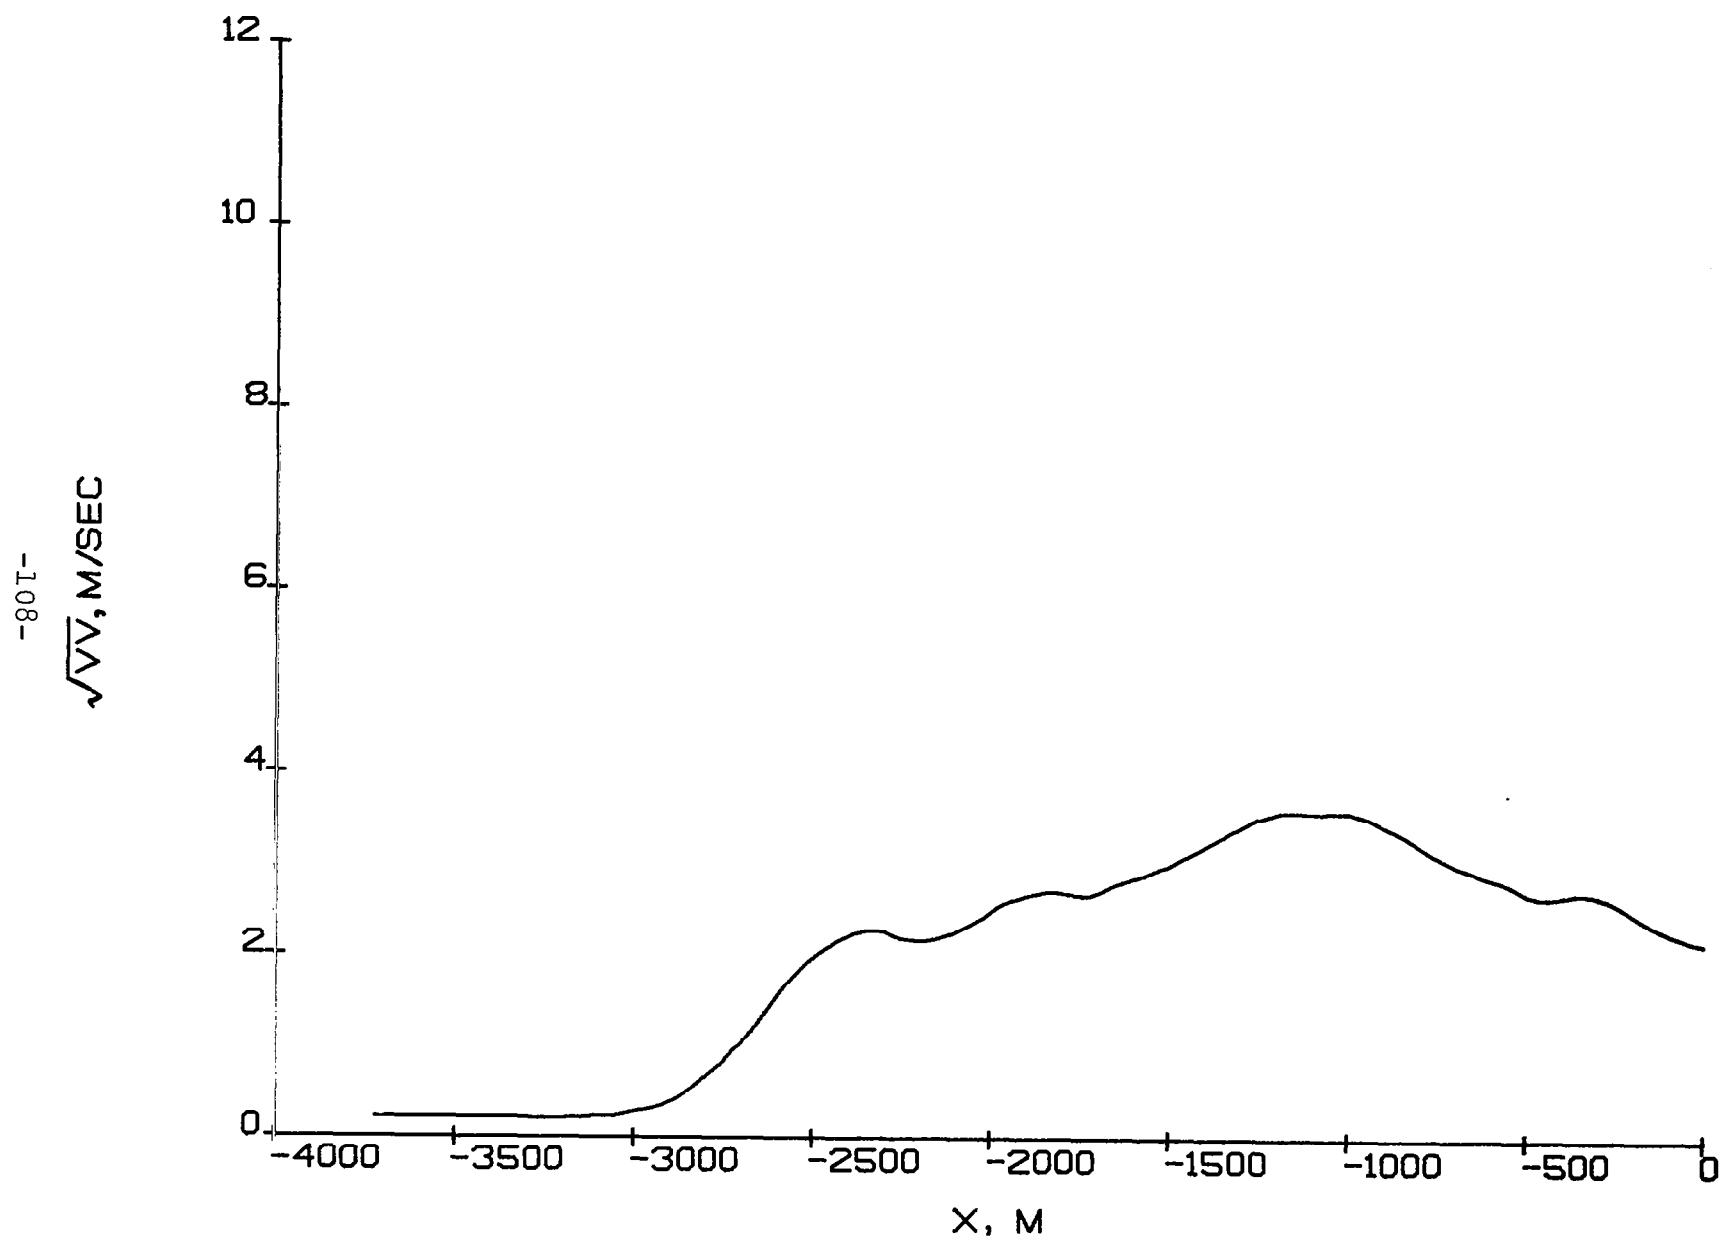
Figure 4.2.13. Variance of the wind perpendicular to runway as a function of horizontal distance from the initial impact point for Denver, Colorado, August 7, 1975 accident.

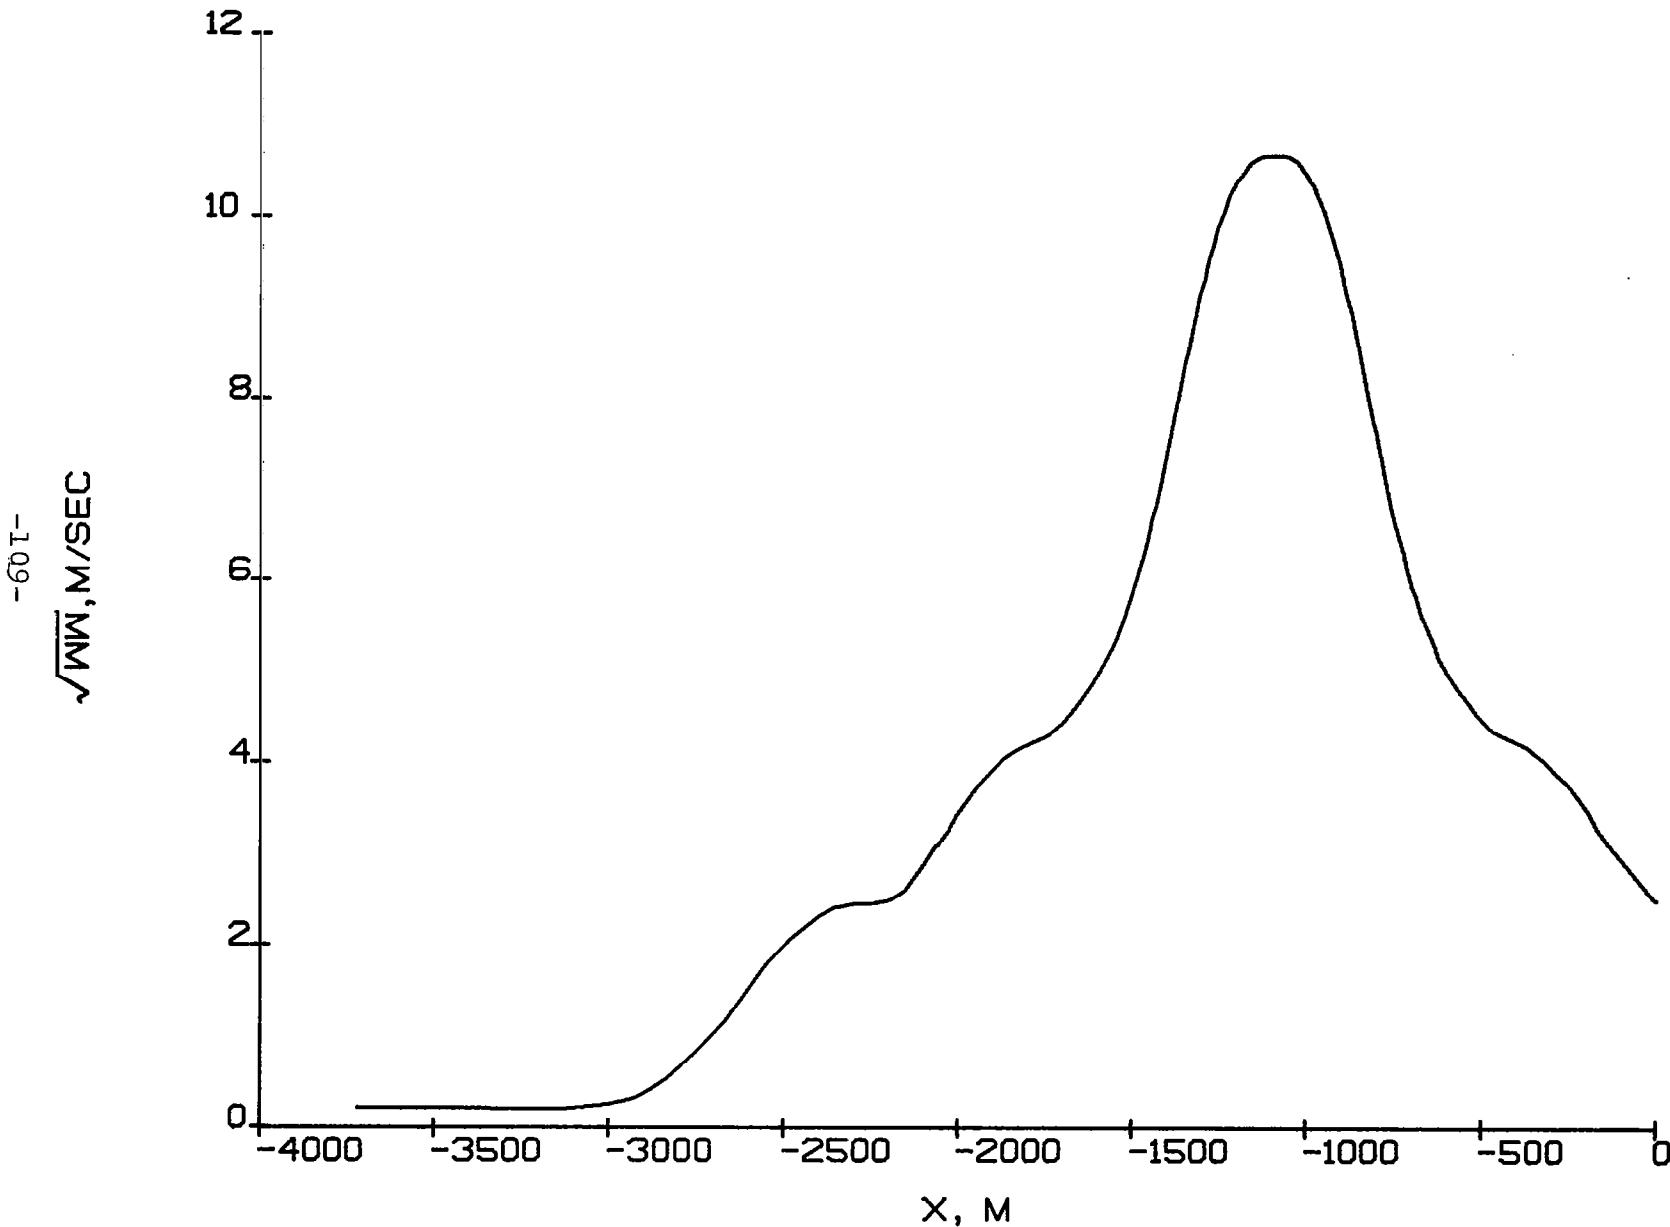
Figure 4.2.14. Variance of the vertical wind as a function of horizontal distance from the initial impact point for Denver, Colorado, August 7, 1975 accident.

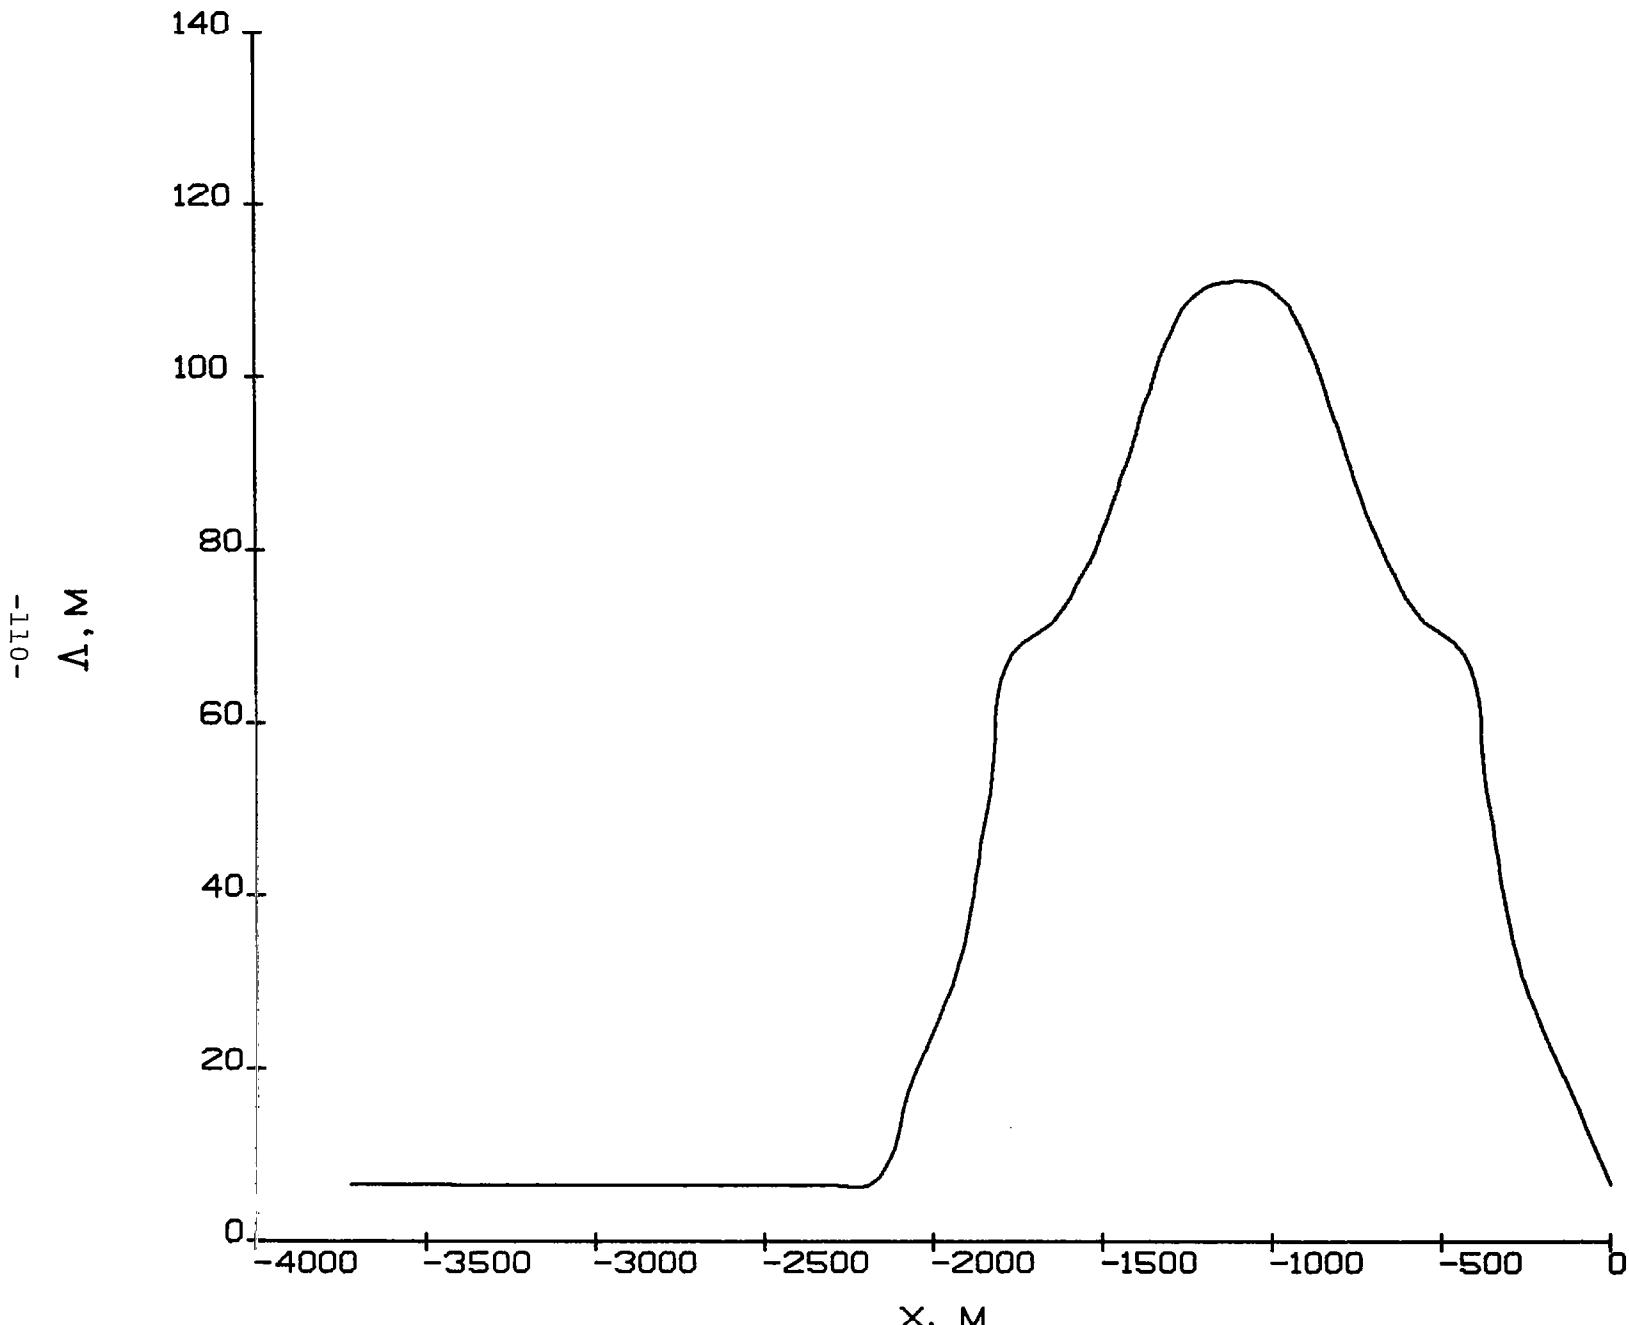
Figure 4.2.15. Turbulence scale as a function of horizontal distance from the initial impact point for Denver, Colorado, August 7, 1975 accident.
